Model: Certain Piaggio models

Subject: new software for multimedia platform 2.0
(accessory p/n 606522M and spare part number 2D000305)

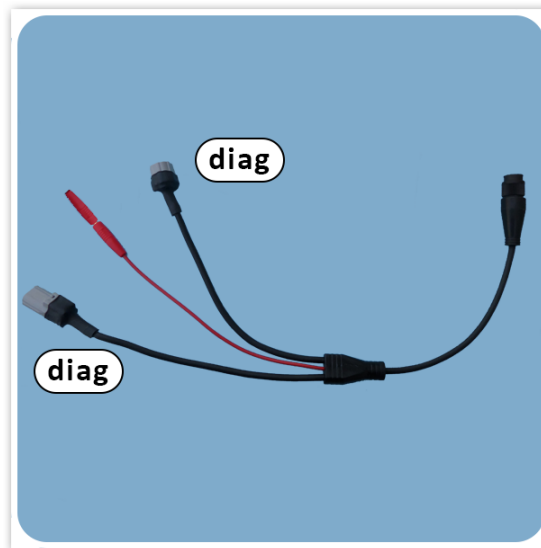
Photo 1 (A-MP interface cable, P/N 021011Y)

The PMP interface cable, **P/N 021011Y** (see photo 1), which is purchasable as an accessory for the P.A.D.S., is required to update the software on the aforementioned models.

Connect the cable 021011Y between the P.A.D.S. tool and the connector of the PMP 2.0 unit (the red wire must not be used and must be insulated) with the ignition switch OFF and then turn the ignition to ON.
